Building Inspection Report

Sample Report

Prepared By:
Viscomi Home Inspections, Inc.
1304 Eynon St.
Scranton, PA 18504
(570) 983-6649

Report Number:
12190901

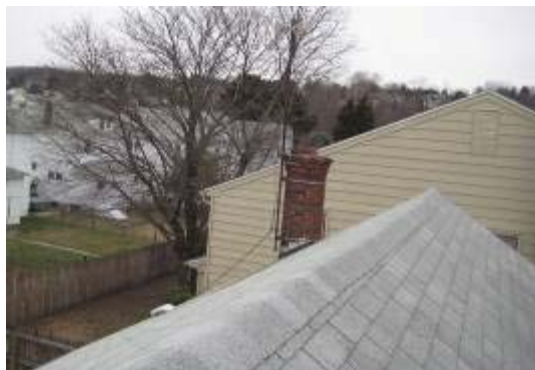
Sloped Roofing

- The age of the roof materials is not known, but the overall visual condition indicates that they are functional. The materials are estimated to have approximately half of their estimated service life remaining. No visible defects were observed.

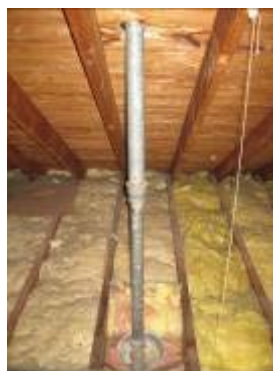
Flashings

- The flashing around the rear plumbing vent should be sealed. Outside light was visible around the pipe from inside the attic. A drain pan is located in the attic below the pipe. The pan was dry at the time of inspection, but this may have potential to leak.

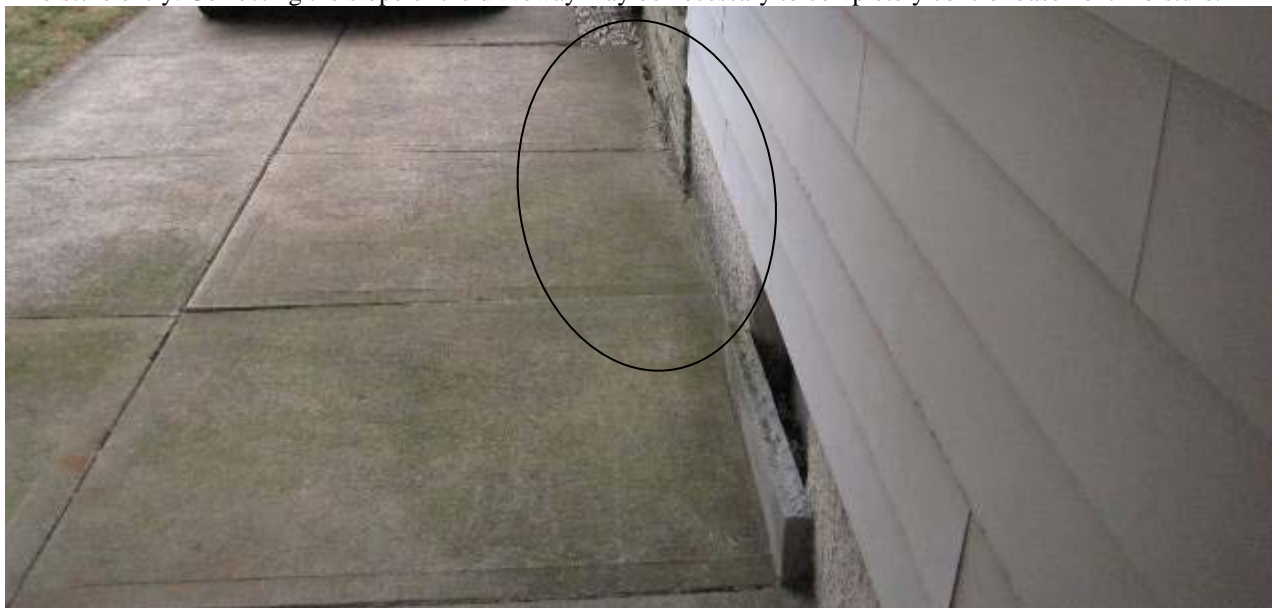
Lot Drainage

- The concrete driveway appears to slope towards the house near the front corner of the home. There is evidence of moisture entry in the basement in this area and active moisture was detected along the basement walls in this corner. The location where the driveway meets the house has been previously sealed, but this is likely not sufficient to control moisture entry. Correcting the slope of the driveway may be necessary to completely control basement moisture.

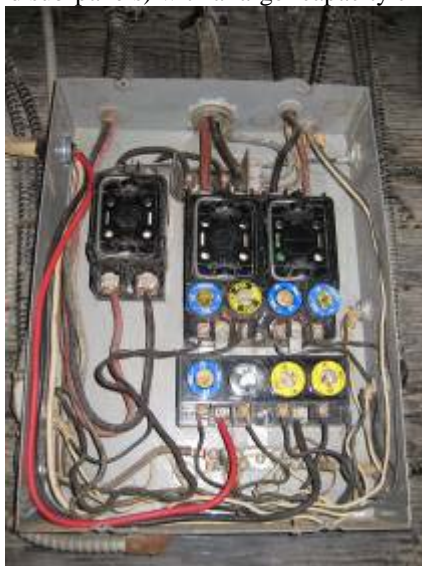
Main Panel

- The main electrical panel is an older style fuse panel. Sub-panels have been added to accommodate additional circuits in the home. Replacing the fuse panel (and sub-panels) with a larger capacity circuit breaker panel is recommended.

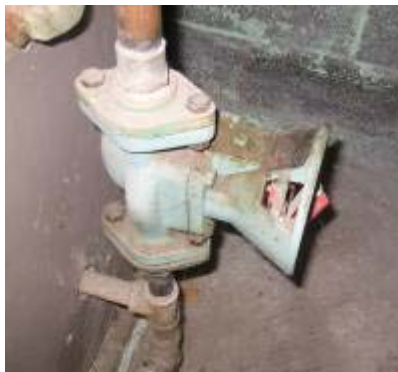
Piping / Radiators

- The circulator pump for the basement radiator piping is disconnected. The basement heat does not currently function and the piping and radiators on this level of the home were not evaluated. This circulator pump requires replacement.

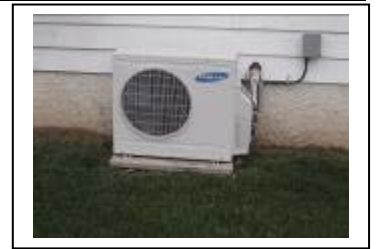
Air Conditioning

- The air conditioning system could not be tested as the outdoor temperature was below 60 degrees F. Damage to the unit could result if operated at a temperature below 60 degrees.
- The insulation installed on the refrigerant lines on the exterior of the home is deteriorated. The insulation on these lines should be replaced.

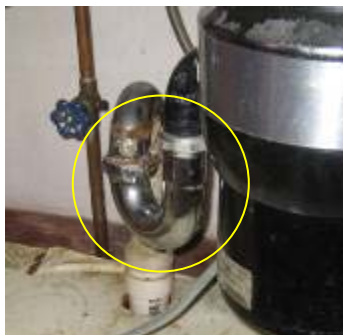
Waste / Vent

- “S” traps have been used for sink drain piping. S traps are typically subject to siphoning problems. The bathroom sink was observed to drain with excess suction. Replacement is sometimes difficult and thus the S traps are usually tolerated. Care should be taken to keep the trap “primed”. Fixtures should be monitored for sewer odor.
- The drain piping below the kitchen sink is rusted and corroded. The connector on one of the pipes is also damaged.
